# Manhole Inspection Summary

Manhole # S11II\_015MH

Insp Date: **1/13/09 3:19 PM**

**Location** Address: **3100 NORTH AVE**

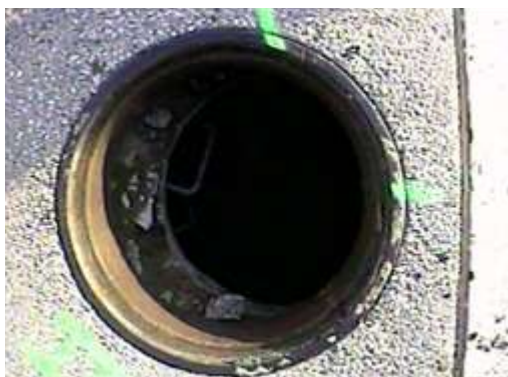
**Frame** Offset: **6** (in.) Condition: ☒ Sound ☐ Cracked ☐ Leaks

FRAME OFFSET

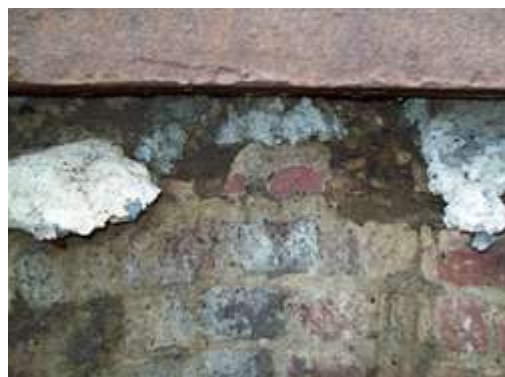
Defect 1

Condition: ☐ Sound ☒ **Cracked** ☐ Root Intrusion ☒ **Loose Brick** ☒ **Deteriorated**

CRACKED, LOOSE BRICKS AND  
DETERIORATED CHIMNEY

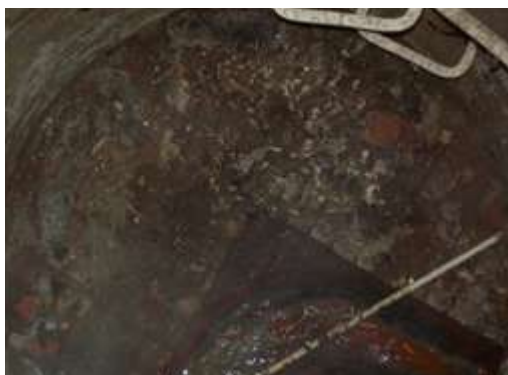
Defect 2

Condition: ☐ Sound ☐ Cracked ☐ Root Intrusion ☐ Deteriorated ☐ Leaks ☒ **Debris**

CHANNEL DEBRIS

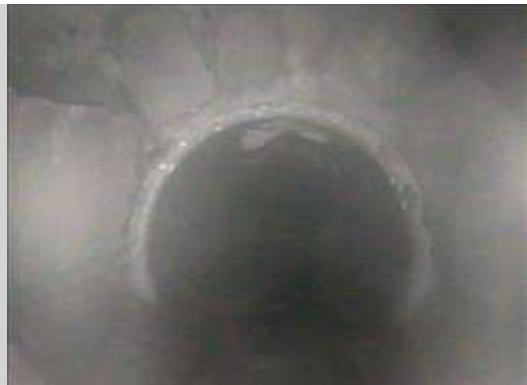
3 O'Clock Inflow

8 in. Circular Gravity Sewer  
Pipe In @ 3 O'Clock

Pipe Height: (in.) Direct  
Pipe Material: **Clay** ☐ Pipe Lined  
Invert Depth: **10.11** (ft.) Flow Characteristics: **Slow**  
Deposits: ☐ None ☒ Mud ☒ Gravy ☒ Debris ☒ Grease  
Silt Depth: **8** (in.) Deposits Extent: **Heavy**  
Infiltration: **None** Pipe Seal Cond: **Unknown**
